NAUGATUCK RIVER BASIN  
WATERTOWN, CONNECTICUT

**MERRIMAN POND DAM**  
**CT 00128**

**PHASE I INSPECTION REPORT**  
**NATIONAL DAM INSPECTION PROGRAM**

JUNE 1980

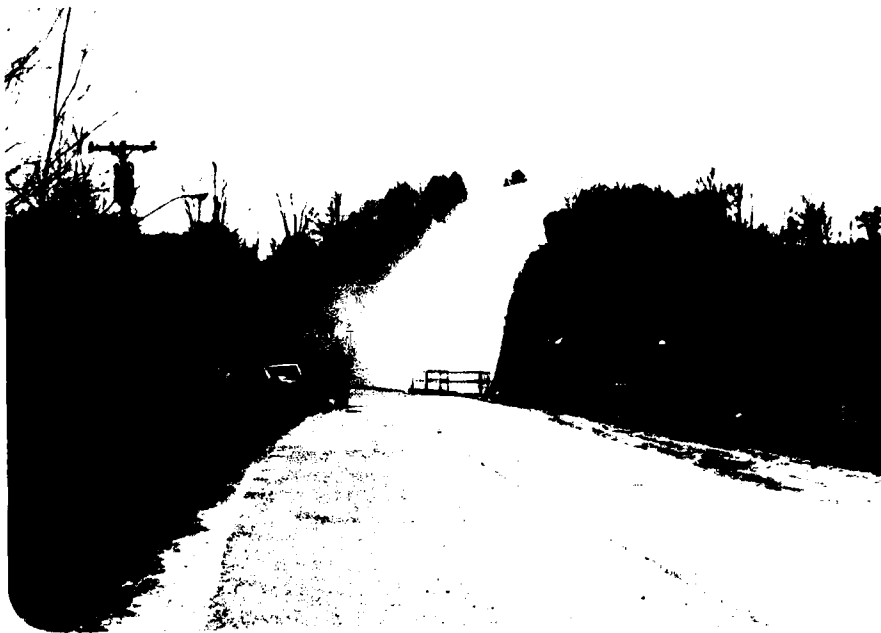
PHOTO NO. 1

A paved roadway covers a portion of the crest, Photo 1. The remaining portion of the crest is grass-covered with numerous areas worn bare by vehicular traffic.

DAM CREST LOOKING TOWARDS SERVICE BRIDGE  
OVER SPILLWAY. NOTE ROADWAY AND TESTING  
OF FIRE FIGHTING EQUIPMENT
